## **Failure mechanisms in turbine blades of a gas turbine Engine –an overview**

**Abstract:-** For the past few decades, the gas turbines have been operated at elevated temperatures to have the advantage of achieving higher and higher power output and engine efficiency. The turbine blade is one of the most important components of the gas turbine and is principally made of Nickel base super alloys. Superalloys are metallic materials for service at high temperatures and the excellent thermal stability, tensile and fatigue strengths, resistance to creep and hot corrosion, and micro structural stability possessed by Nickel-base super alloys render the material an optimum choice for application in turbine blades. The main function of turbine blade is to translate thermal energy of gas at high temperature and high pressure into mechanical work. The gas turbine blades operate at very high temperature under conditions of extreme environmental attack and subjected to degradation by oxidation, corrosion and wear etc. Generally, during operation, the turbine blades are subjected to the failure mechanisms like Fatigue, Creep, Corrosion, Erosion and sulphidation etc. The failure of turbine bl

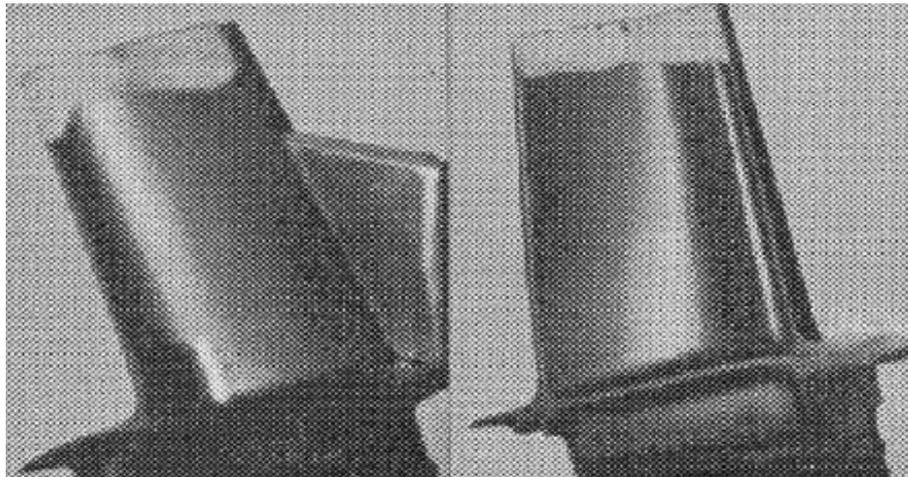
It is understood that under normal conditions, turbine blades should never be operated at excessive temperatures for long enough periods to cause micro structural damage. Some elevated temperature exposure is permitted for very limited periods, for example during start or for emergency situations. Such exposure should be strictly controlled, with inspection for possible damage, including metallographic examination of sample blades, being required. Once the microstructure has been degraded by exposure to elevated temperature, it is normally assumed that the blades have been damaged and replacement is mandatory. Exposure to creep can be detected by metallurgical tests, common indicators being the coarsening of the gamma prime precipitates and the formation of void cavities at grain boundaries. Details on creep may be found in Greenfield (1972). Often creep failures can be associated with a loss of cooling. This loss can be due to a quality control problem (such as blocked cooling passages) or due to a blockage or malfunction of the cooling airflow.

**Figure.3: Cracks of the Turbine blade due to creep**

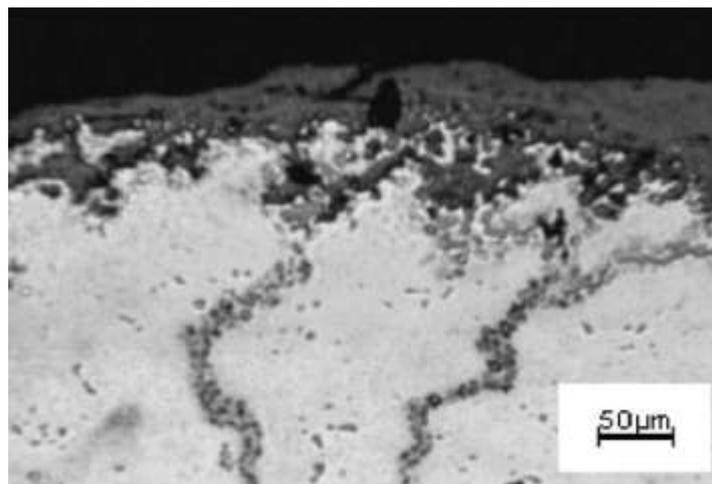
**Figure.4: Type I hot corrosion, grain boundary diffusion and subscale sulfide particles are seen.**

The high pressure side of the blade is a favourable location for the start of the type I reaction because sulphur rich gas entrained contaminant strikes this location first [26]. In another study it was confirmed that in most of the gas turbine blades, HTHC occurs away from the edges (i.e. middle of airfoil). With increasing height from the platform, the extent of this type of corrosion increased [27].

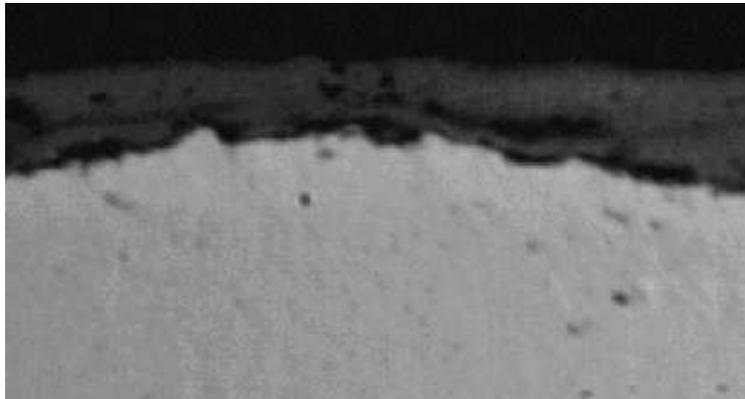
**Figure.5: Type II hot corrosion, no grain boundary diffusion and subscale sulphide particles are seen.**

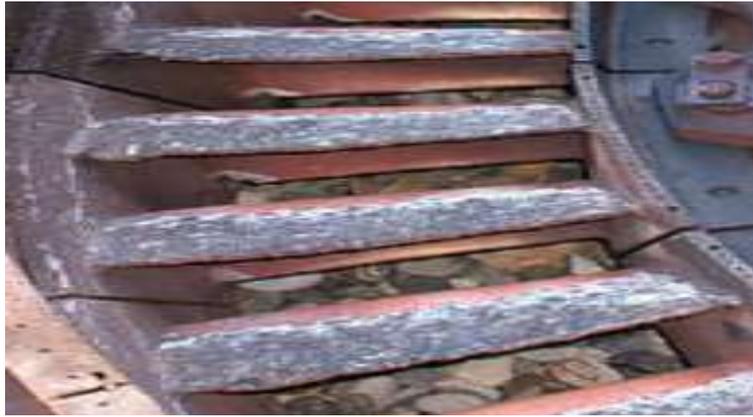
This case relates to a gas turbine plant with a capacity of 150 MW and the turbine was operated for about 1860 hours during a period of 3-year time, with 65 times started up. The plant is located a short distance from the sea. It was observed that some of the stationary and moving blades were get damaged by solid objects and particles, which might be originated from the destroyed blades of the 1st row. After inspection of the blades, it was observed a deep damage on its surface, caused by foreign bodies, probably coming from the deteriorated moving blades of the first stage, located upstream. Figure.6 illustrates the diaphragms of the second turbine stage of gas turbine engine.

**Figure.6: Erosion of gas turbine blade**

This shows that the surfaces of the diaphragm blades present severe damage, caused by foreign bodies (solid particles). It was found that the damages of blades of subsequent stages were caused as a result of disintegrated materials coming from moving blades of the first stage. It is argued that some of these blades might first get fractured damaging subsequent blades of the turbine gas Path. Analyzing the results of the visual inspection, it could be concluded that the moving blades of the first stage fractured first and damage the blades of the later stages. Other damages were a direct consequence of the disintegration into small fragile particles of the first stage moving blades. That disintegration caused a stream of small foreign bodies and solid particles, which eroded some surfaces of the turbine blades [30].
