Load Capacity and Field Assessments of Concrete Bridge before Strengthening

Keywords:- Field investigation, concrete T-Beam girder, site inspection, Zhong Xing Bridge.

Zhong Xing bridge is located in the G221 National Highway (Harbin – Tong Jiang Road) at the Da Lou Mi town /China , bridge length 96 meters, 4 spans, simply supported of 20-meter reinforced concrete T beam layout of $8.0 + 4 \times 20.0 + 8.00$, the T-shaped main beam has connected laterally with rigid connection. Deck width is $7 + 2 \times 1.75\text{m}$ sidewalk, design load criteria of the two levels, vehicle No.-15, and truck No. 80. The environmental categories is II, deck longitudinal slope of 1.0%, the transverse deck cross slope: 2.0% of two-lane, the reinforced concrete T-beam using R25 concrete type and reinforced concrete piers and abutments were R20 concrete type. The bridge was built in 1982 has been used for about 30 years ago.

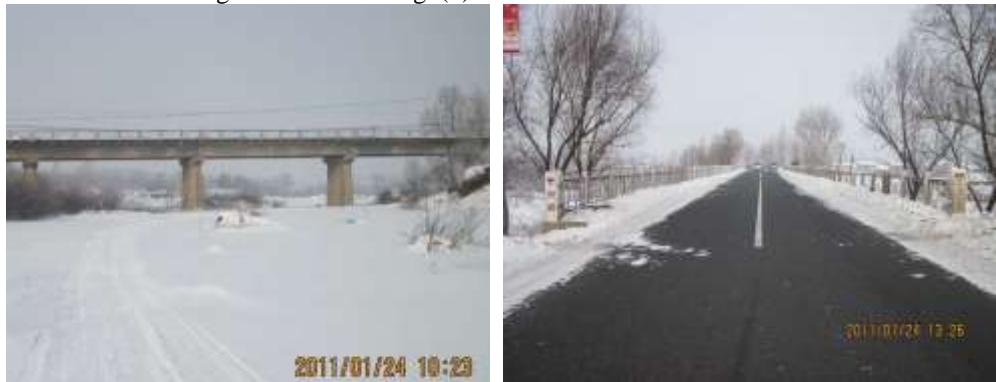
Fig. (1) Zhong Xing Bridge

The reinforcement and renovation process project was carried on the Zhong Xing Highway River Bridge. General views of bridge are shown in Fig. (1).

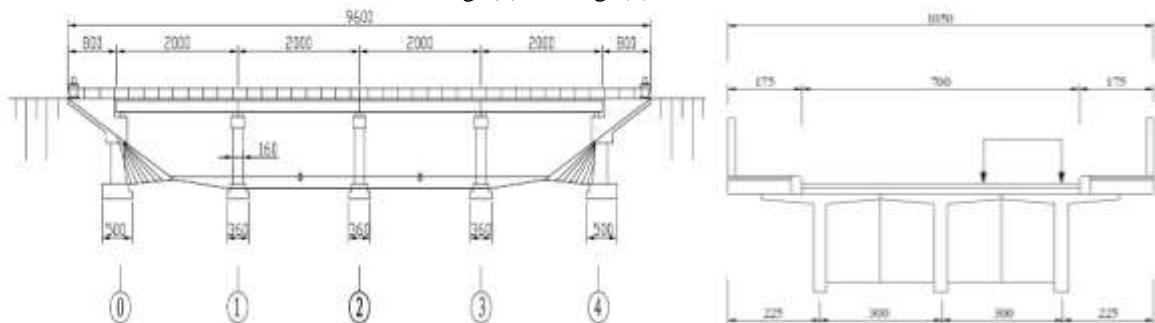
Fig. (2) bridge details (cm).

The original design deck is 10cm thick cement concrete pavement. In 2009 the original cement concrete deck pavement affixed asphalt concrete pavement, thickness 8cm. The support bed is a flat bed rubber bearing, bearing dimensions of $20.0 \times 20.0 \times 2.8\text{cm}$;

The Zhong Xing Bridge general layout, structural details of bridge superstructure and bridge substructure elements details are shown in Fig. (2) and Fig. (3).

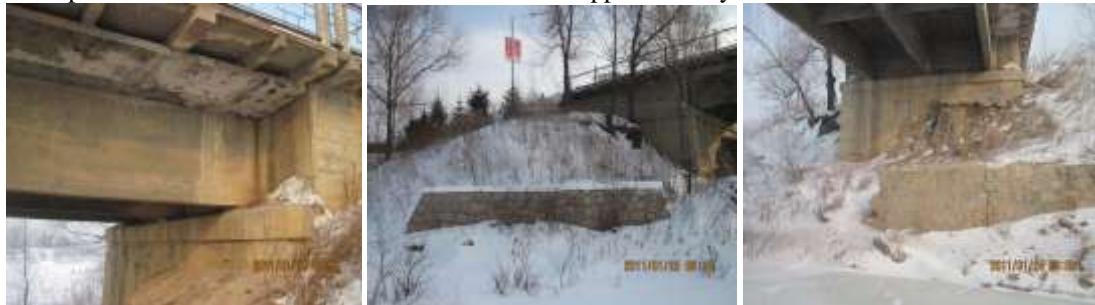
Fig. (10) Wing walls and ear wall damaged condition

Fig. (10) shows the side wall with the abutment back wall connection, no obvious damage fracture, short local presence fine cracks and its maximum width of approximately 0.1mm.

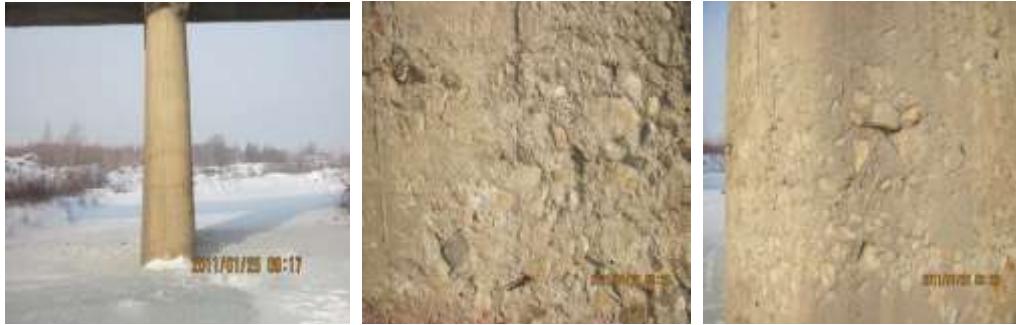
Fig. (11) Peel of the cement mortar and exposed gravels of pier condition

The site inspection results show that during the wet period washout lead to large defect of abutment truncated cone and also paving defects and other undesirable phenomena. The typical failure condition is shown in Fig. (11).

The state of abutment back wall concrete structure has admissibility cracks, exposed tendons, frost damage, etc. Defects also include cone slope protection. Abutment based on the basic integrity of overlying soil and no exclusive symptoms.

Since the bridge exposed to water flow of river over 30 years ago, the pier was suffering from different damage levels. Furthermore, the concrete gravel was exposed due these reasons and other undesirable phenomena. Smooth and fine cracks exit on the pier body, maximum crack width about 0.1mm. Fig. (12) shows the pier condition.

7. Re-paved bridge abutment the cone slope protection, reduce the wet period Washout Bridge station.
8. It is recommended to set a defense riverbed erosion dams, site about 10 to 20 meters of the bridge downstream dams and restore the riverbed height to the original status (cap top surface elevation +0.50 m) to overcome the technical problem effect on bridge pile cap Leakage.

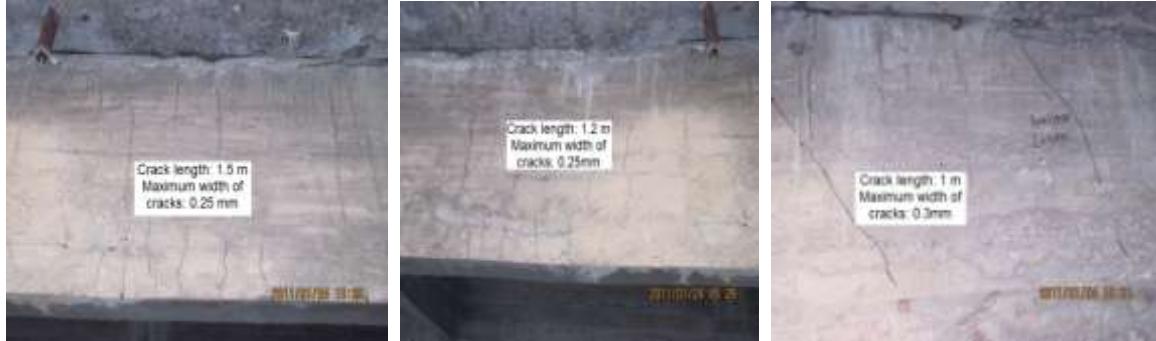
Fig. (17) Bending and diagonal tensile cracks pattern.

The main beam No. 1 and No. 3 (left and right side of the bridge) are prevalent in the mid-span about 2 meters within a through T beams rib, crack spacing lies between 20 – 50 cm, most common about 25 cm spacing. Crack pattern showed the upper part were narrow while lower parts have larger crack width due to flexural tensile effects. The width cracks distribution was between 0.1mm ~ 0.28 mm and crack width exceeding 0.25mm only at vertical crack. The longest crack was at the beam rib has been extended to the flange of the beam, about 1.5 meters length. Fig. (17) shows the cracks pattern.

The maximum width vertical cracks occurred at the mid span ($L/2$) near the longitudinal reinforcement was around of 0.25 mm, while the maximum width of diagonal cracks at the end has reached 0.3mm. The flange of beam have a local vertical and horizontal structural cracks, steel corroded and concrete cove has fall off; the foundation of the pier have leakage at the river bed about 50cm and bridge on the downstream riverbed dredging cause serious foundation erosion phenomenon. Due to increase in the traffic load and riverbed sand-digging, and the possibility of further developing the damages listed above, therefore, the bridge has a certain degree of

1. Strengthening of reinforced concrete T-beam to increase the carrying capacity of the bridge.
2. Because of the steel corrosion, concrete cracking and dropping parts, the appropriate patch must be carried out to spray with high toughness and anti-corrosion materials to improve the durability of the reinforced concrete structure.

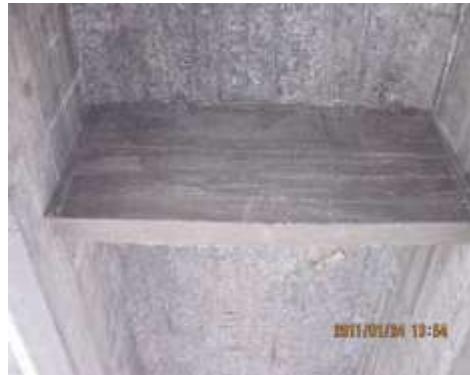
Fig. (19) Diaphragm beam conditions detailed

Two set intermediate diaphragm was installed at left and right ends of the beam, a total is four diaphragm beams. They are made of a rigid connection monolithically poured with main beam girder. The field investigation found no structural cracks and corrosion, concrete cover have damaged. Fig. (19) show that all diaphragm beam in a good condition.

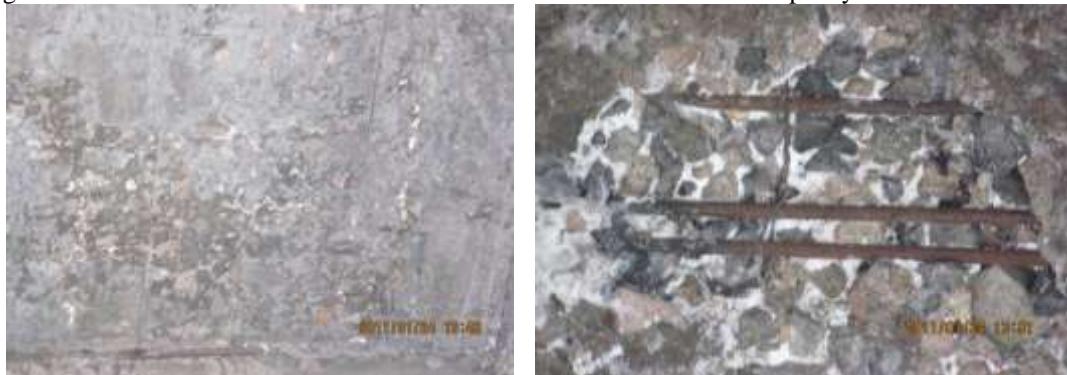
Fig. (20) The flange cracks, water seepage whitened condition and steel corrosion.

The field survey showed that the main T- beam flange, web and diaphragm beam were whole cast at same time during the construction process, Therefore there is no crack and local leakage which can causes whitened area as shown in Fig. (20).

However, the flange plate exposed to the direct effect of cyclic loading and large area of flange plate have cracks, water seepage whitened as well as frozen which lead to a reinforced fall off the concrete cover causing steel corrosion. However these defects will lead to reduce the section capacity.

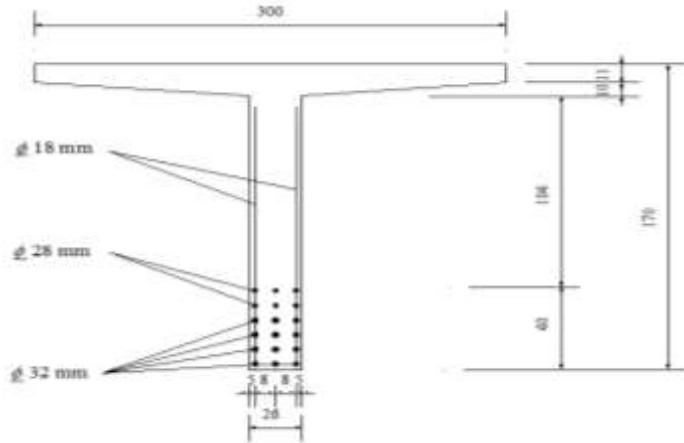
Fig. (22) Cross-section reinforced beam layout (unit cm).

The main beam longitudinal bar diameter is 12φ32mm and 6φ28mm, and the diameter of the stirrup φ18mm; the average concrete beam cover at bottom was 29.1mm, and at the side of around 25.1mm. Fig. (22) showing beam reinforcement details.

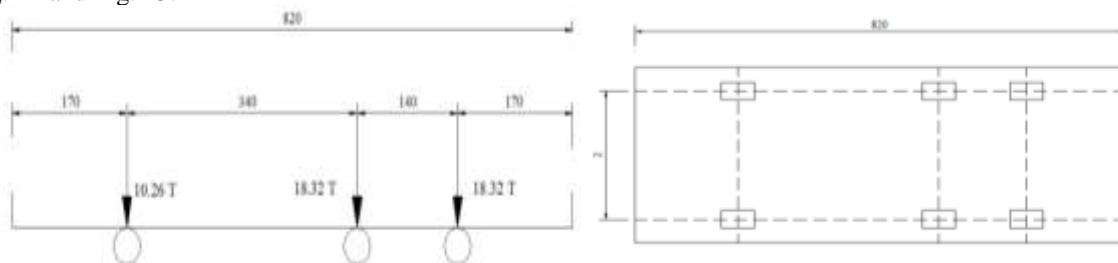
Fig. 24 Load schematic diagram test vehicles (black A7)
(Unit: cm, ton)

The test loads used as the experimental load were two heavy-duty carrying timber vehicles, as shown in Fig. 24 and Fig. 25.

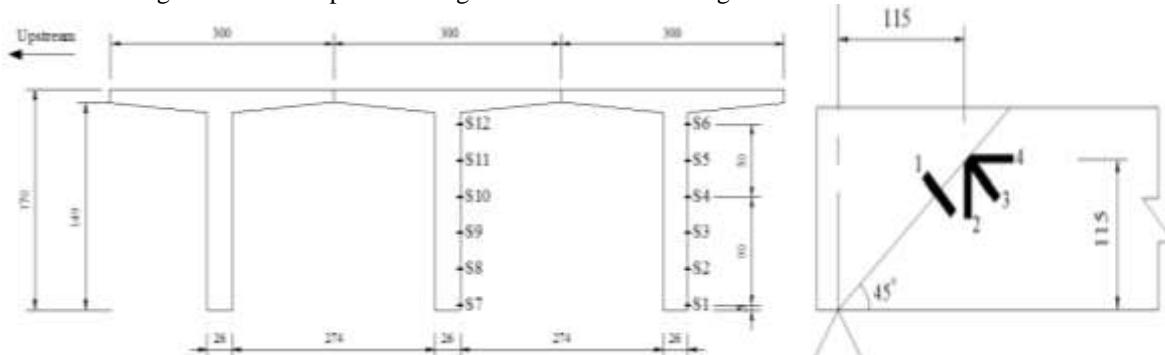
Fig. 28 Cross-section strain measurements point layout

Strain measuring of main beam points arrangements are shown in Fig. 28.

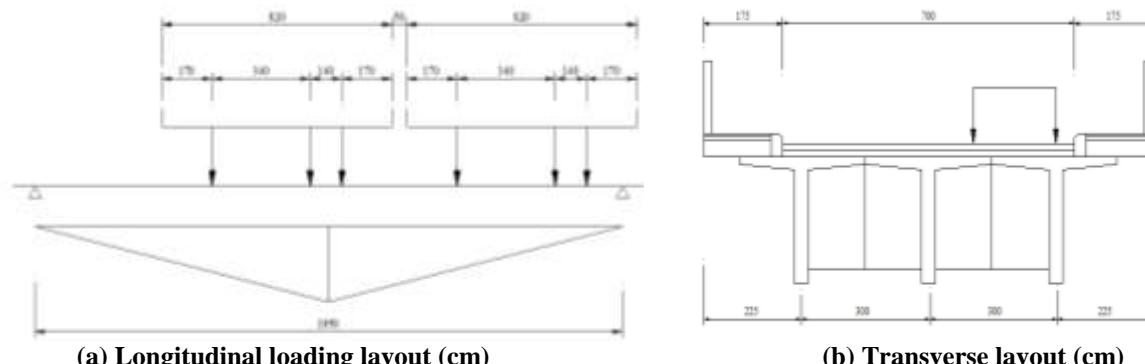
Fig. 31 Loading Case I conditions test layout.

Various conditions in the load test arrangement are shown in Fig. 31.

(a) Longitudinal loading layout (cm)

(b) Transverse layout (cm)

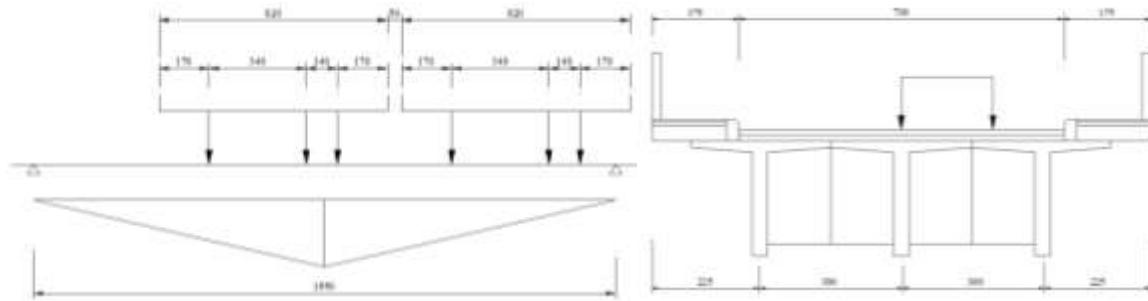
Fig. 32 Loading Case II conditions test layout.

(a) Longitudinal loading layout (m)

(b) Transverse layout (cm)
