An ergonomic study of work related musculoskeletal disorders among the workers working in typical Indian saw mills

Anas Ali¹, S.M.Qutubuddin², S.S.Hebbal³, A.C.S.Kumar⁴

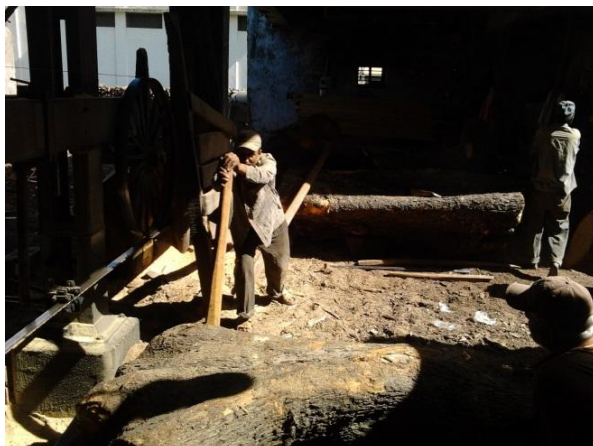
Fig. 1 Worker moving the log manually Band saw

Pictures 1 & 2 shows worker moving the log of wood in the horizontal band saw with the help of levers. From these postures this can be inferred that the due to heavy load of the log there is lot of stress on the back and arms of the worker which is substantiated by the REBA score of '9' which indicates high risk and a need of immediate ergonomic intervention. This method of moving the logs with the help of levers is the only means of moving the logs apart from the hand carriage vehicle; no powered vehicles are used for this purpose. A worker has been seen moving these logs frequently from the unloading point to the carriage of horizontal band saw.

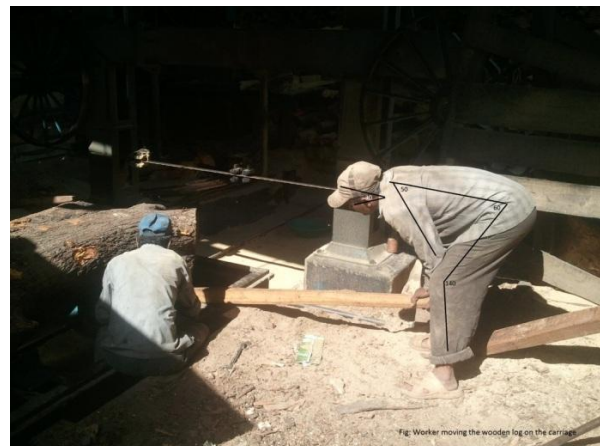
Fig. 2 Worker moving the wooden logs on the horizontal

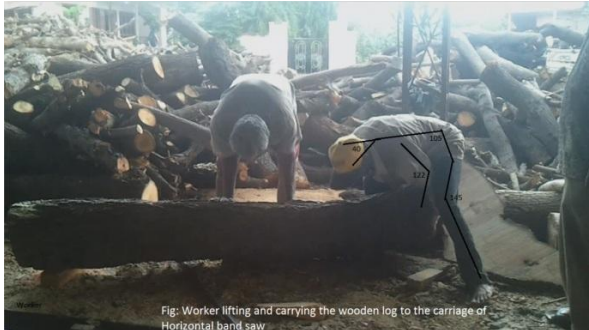
Fig. 3 Workers lifting and carrying the wooden logs from Unloading area

Figures 3 & 4 are more examples of improper postures of the workers in moving the logs, With REBA scores of '10' and '9' respectively, further more from the picture it is observed that the frequent bending to lift the log is hazardous to the back in long run, both indicating the need of immediate ergonomic intervention.

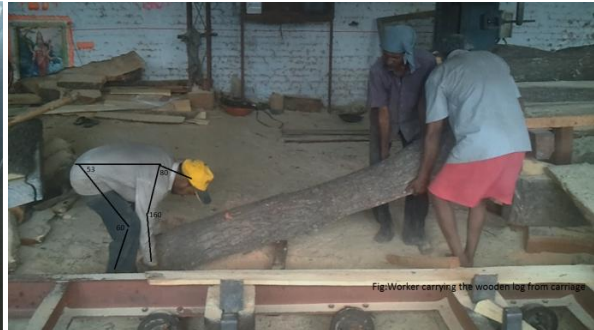
Fig. 4 Workers bending and lifting the heavy logs frequently.

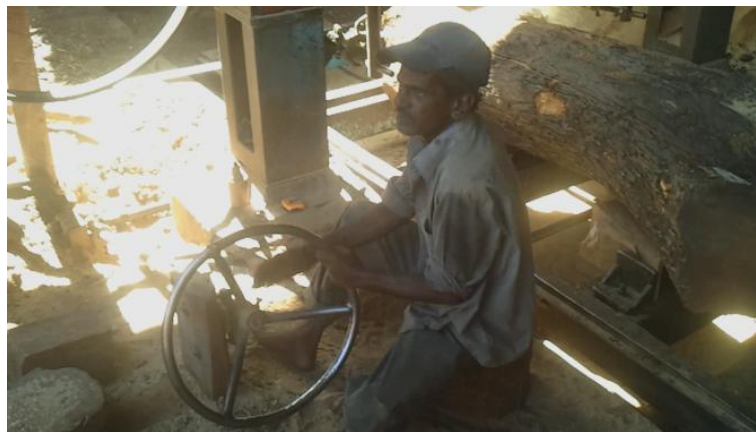
Fig 5. Worker moving the carriage of band saw using lever

Figures 5. shows the operator moving the carriage using rotary lever. It was observed that QEC would be better tool as it includes both observer's assessment and worker's assessment. It was seen that the total score was '70' suggesting further investigation. The worker is required to be seated without the back support and constantly move the carriage for prolonged time.

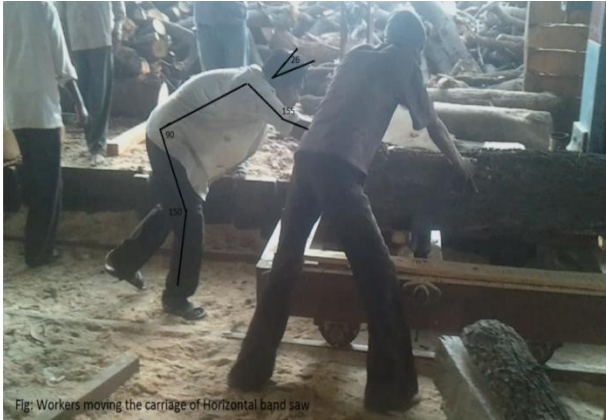
Fig 6. Workers manually moving the carriage

After the first cutting of complete log, the carriage of band saw is returned by the worker as shown in figure 6 and the feed is given to the saw blade or in other words the saw blade of the band saw is lowered by the operator as shown in figure 7. Applying RULA on the fig 8. Gave the score of '7' suggesting high risk and immediate need of change, although not for prolonged time but this is done frequently say every 10 mins, for every cut on the wooden log.

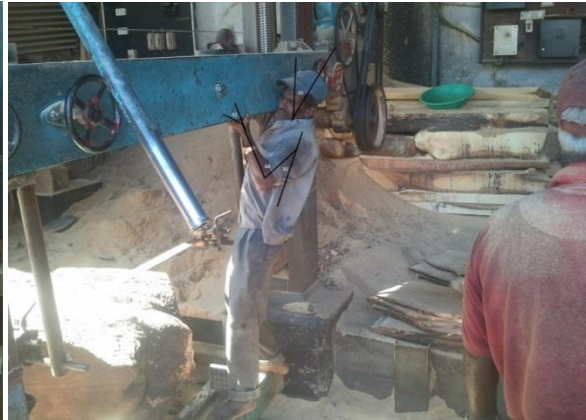
Fig 7. Worker giving the feed to the horizontal band saw

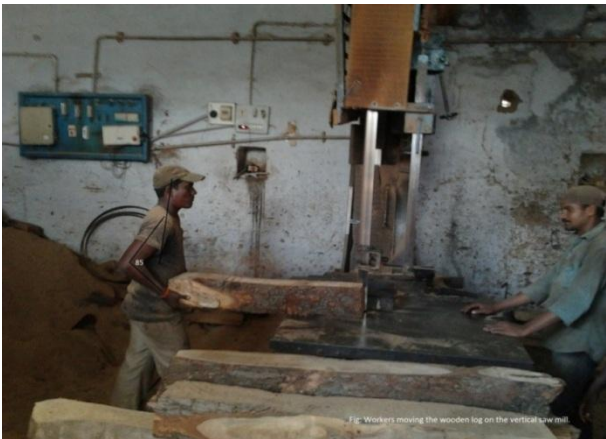
In case of small wooden logs chain saw and vertical band saw machine is used instead of horizontal band saw as shown in pictures 8 and 9 respectively. Both the postures giving the REBA scores of 3 and 7 respectively. While observing the employee using the chain saw it is inferred the either of the shoulder is abducted or raised causing a hazardous posture which may result in MSD's.

Fig 8. Worker working on the vertical band saw

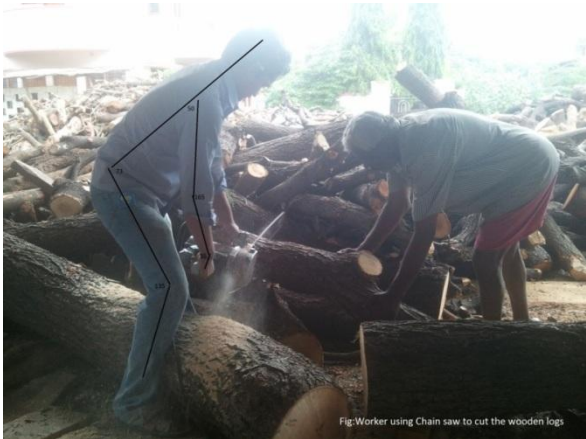
Fig 9. Worker using the chain saw to cut the wooden logs

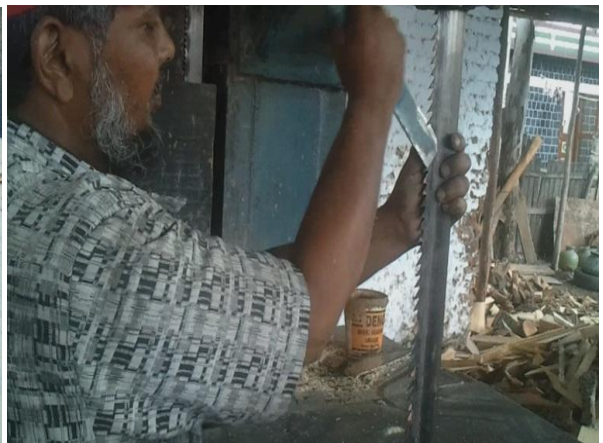
For the cutting operations to carry out smoothly the blades of the saw machines needs to be constantly sharpened using files and grinders. Figure 11 shows the worker sitting without a back support and arm support and grinding the saw blades for smoother cutting. Fig 12 showing the worker providing the zigzag pattern to the blades of the vertical band saw because it pushes the wooden log down on the work table, this is done after almost every hour. Applying strain index for the clip of cycle duration 78 seconds the strain index for right hand is much high i.e. above 60 and for left hand is below 3. Hence safe for the left hand but unsafe for the right hand.

Fig. 11 Worker giving zigzag pattern to the saw blades

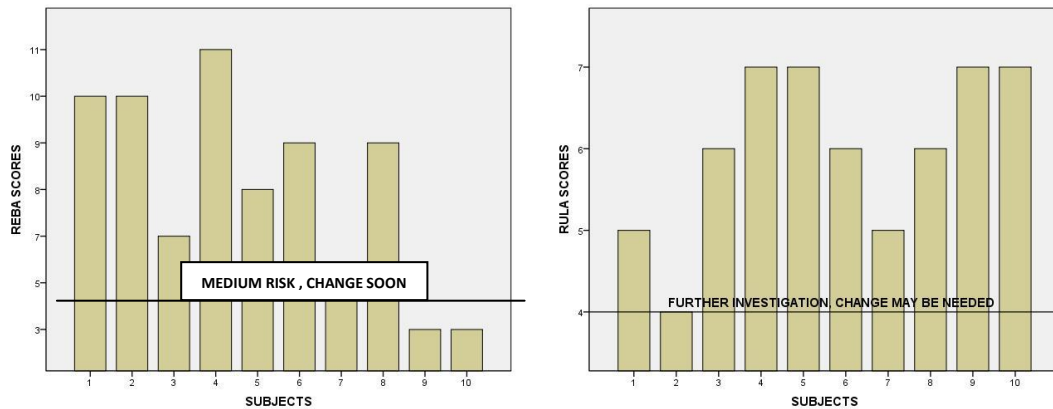
The above graph shows the RULA and REBA Scores for 10 subjects, it indicates that posture scores of most workers are well above the assumed safe scores hence immediate change or ergonomic intervention is needed in the current workplace. Rapid Entire Body Assessment (REBA) (Hignet and McAtamney, 2000) and Rapid Upper Limb Assessment (RULA) (McAtamney and Corlett, 1993) working posture analysis were used to analyse the postures and the associated risks. REBA scores (Table 1) were very high (11/11) in the sections where log shifting is done manually by the workers. RULA scores were consistently high in all the sectors. Average RULA score was 6 and Strain Index (Moore and Garg, 1995) was applied to get an insight into repetitiveness of the job and the resulting strain on the limbs. Value was very high in the sharpening operation on the saw blade (70), The results of this study revealed that the saw mill workers are engaged in rigorous hand intensive jobs, leading to various MSDs primarily affecting the upper extremity of the body. It can be observed from the present study that work-related incidents affect different body parts of the workers. This has also lead to a high rate of workday loss. It has also been observed that unskilled workers fail to keep their commitments because of absenteeism.
